## MOISTURE-RELATED BUILDING DEFECTS IN HERITAGE BUILDING: A REFURBISHMENT-BASED ASSESSMENT

Moisture-related building defects in Penang's heritage buildings persist despite refurbishment efforts, posing threats to structural integrity, aesthetics, and occupant comfort. This problem is exacerbated by tropical coastal conditions, stringent conservation guidelines mandating original materials (e.g., lime), and the inherent vulnerability of aged structures. This study employed a mixed-methods approach, combining field surveys (thermal imaging, humidity tests) and user questionnaires across three refurbished heritage buildings (hotel): 23 Love Lane (strict WHS compliance), Jawi Peranakan Mansion (moderate), and USM Guesthouse (weak compliance). Quantitative data were analyzed via SPSS (descriptive statistics, chi-square tests). Key results revealed: (1) Moisture-driven defects (dampness, fungi, peeling paint) recurred in all buildings, with severity highest under strict compliance (27 defects at 23 Love Lane); (2) Weak-compliance USM Guesthouse used cement, reducing moisture ingress but violating authenticity; (3) User surveys identified peeling paint discomfort as significant concerns

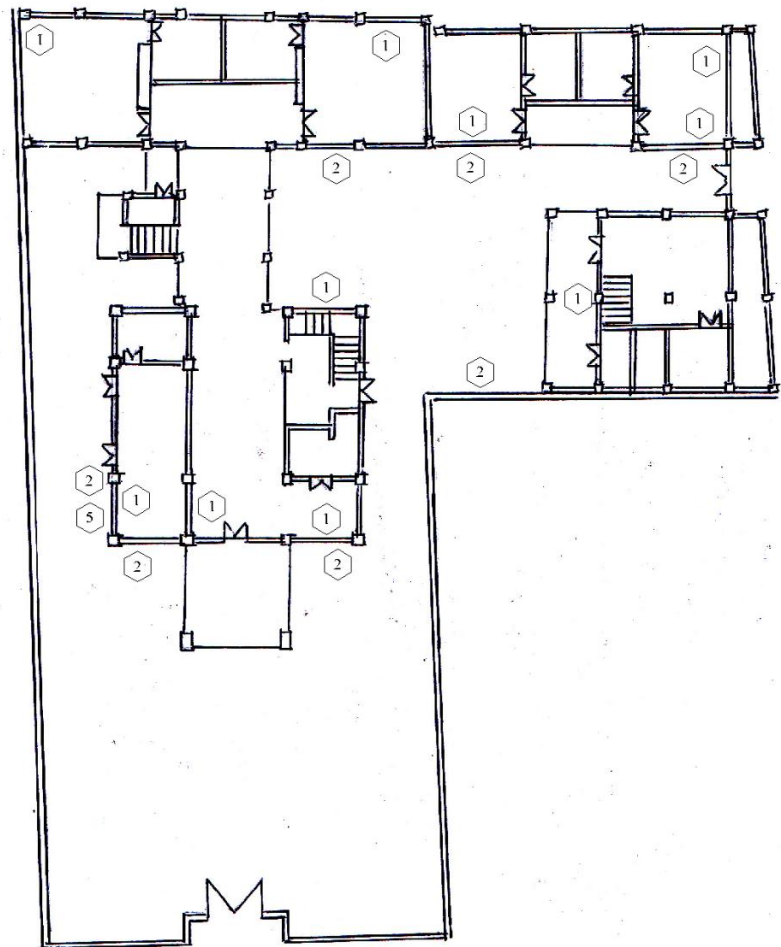
Based on observation, the condition of 23 Love Lane Hotel is undergoing some defect in some parts of the building as shown in Figure 2. This condition started to look after a period of 3 years of hotel operations after refurbishment process finished by the end of 2011. Some of the defects seen in buildings are cracking (non-structural), dampness, fungi/mould, timber decayed, peeling paint and leaking (roof) as shown in Table 1.

**Figure 2.** The spread of building defect on the ground floor plan  
Source: Individual Analysis, (2025).

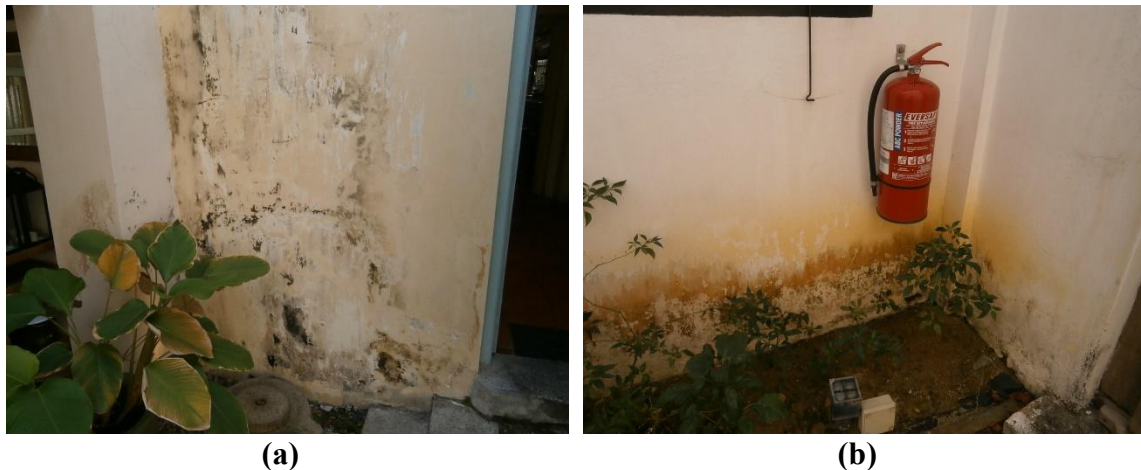
**Figure 3.** Fungi/mold visible on outside of building:(a) near Indian Shophouse and (b) part of Jack annex roof  
Source: Individual Analysis, (2025).

Growth of fungi/mold at 23 Love Lane Hotel is located on the outside of the building. Its presence can be found in some parts of the building, such as Anglo-Indian Bungalow; Straits eclectic annex; Indian Shophouse; and Jack annex roof as shown in Figure 3.

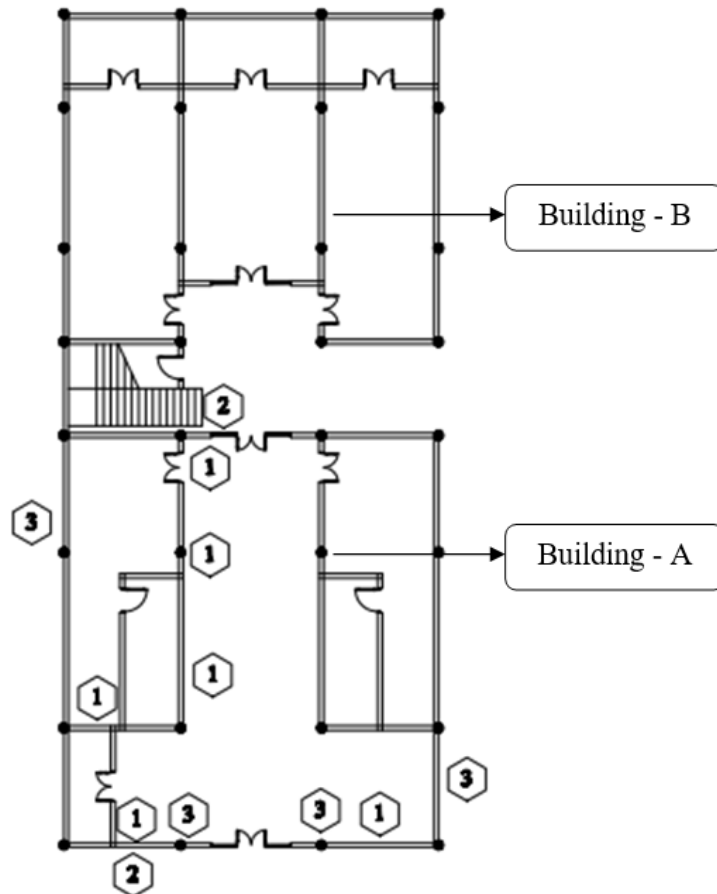
Dampness manifestations are visible at multiple locations throughout the building. Dampness occurring in Buildings - A (front building in Figure 4) is caused by the retention and structural formations of the old building. The building's proximity to a water source (within 3 feet/0.9 meters) creates favorable geographical conditions for moisture infiltration, particularly affecting vulnerable structural elements.

Two spots of fungi/mold growth at Jawi Peranakan Mansion is located on the facade of Building – A (front building). Based on observation in Table 2, the emergence of fungi/mold is caused by higher moisture content, less of sunlight and higher humidity. The growth of fungi/mold in Jawi Peranakan Mansion is not alarming, yet preventive action is needed to keep the building appearance and occupants healthy as shown in Figure 5.

**Figure 4.** Building defect layout plan on Jawi Peranakan Mansion  
Source: Individual Analysis, (2025).

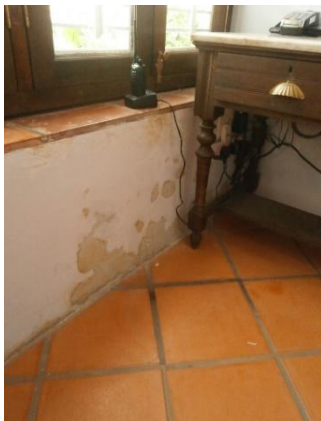
**(a)**

**Figure 5.** Conditions of dampness after repaired: (a) receptionist room and (b) main hall  
Source: Individual Analysis, (2025).

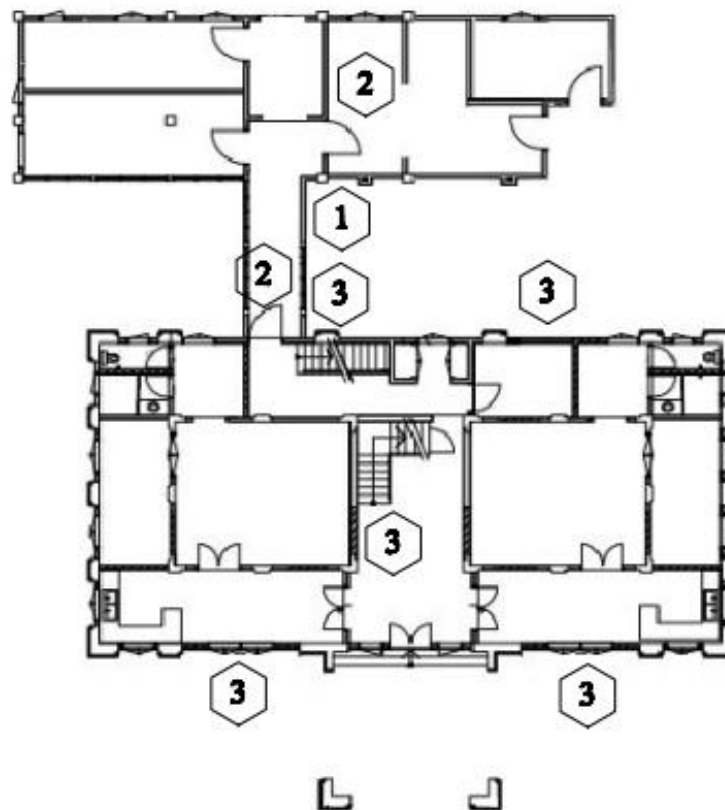
**Figure 6.** Building defect layout plan on USM Guesthouse  
Source: Individual Analysis, (2025).

Based on observation, the condition of USM Guesthouse (Figure 6) is undergoing some defect in some parts of the building. This condition is found at some point. Some of the defects seen in buildings are fungi/mould, timber decayed, peeling paint, leaking and termite attack as illustrated in Table 3.

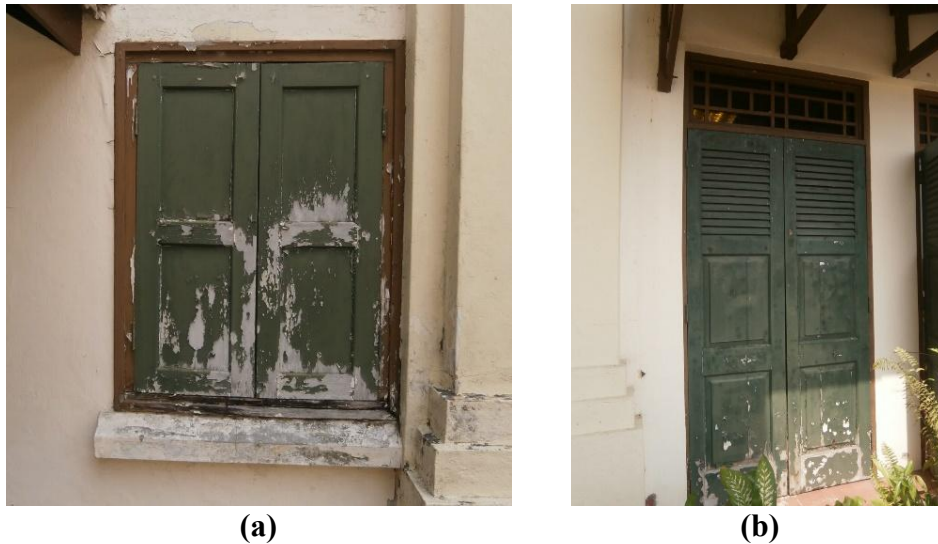
The presence of peeling paint on the USM Guesthouse occurs on the inside and outside of the building. As known, paint peeling occurs on building façade. In this building, peeling paint occurs on doors and windows (Figure 7). While on the walls, paint peeling occurs inside and outside of building, but the intensity is very low.

**Figure 7.** Peeling paint condition on: (a) window and (b) door  
Source: Individual Analysis, (2025).
