## FROM HISTORY TO DECAY: CONDITION SURVEY OF FACADES ON KARET STREET, SURABAYA

**Darrell Immanuel Tjia<sup>1</sup>, Kenny David Ariyanto<sup>2</sup>, Stephanus Wirawan Dharmatanna<sup>3\*</sup>**

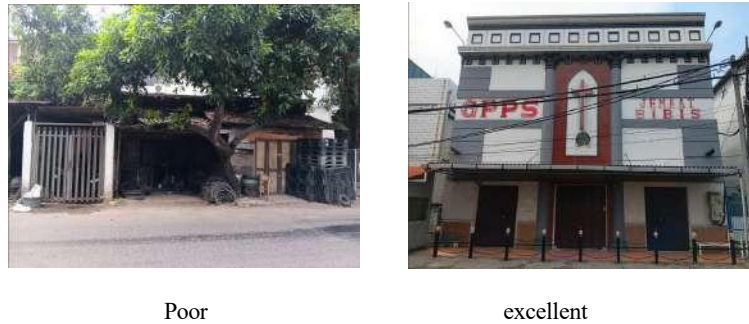
Three buildings located in zone A have poor qualities, that makes zone A as the most deteriorated zone amongst the others. These buildings have low intensity of usage, as the result of functions with inactive tendency, such as tire service and storage. Therefore, the upkeep and attention to these buildings are minimal in nature, which makes the damage of the buildings progressively fast. The conditions are worsened by vehicular traffic and congestion that bring along the pollution, accompanied by limited maintenance from the building owners. On the other hand, the buildings in active areas with functions such as trading and commerce tend to be far more well maintained. The commercial activities make the building owners care more about the maintenance, and therefore, the buildings show much better performance. There are fifteen buildings in good condition and six that are classified as excellent, specifically in zone I.

In zone F and G, we can find mixed function buildings with higher value on historical traits that are still well maintained with good performance. Other well maintained buildings can be found in zone C and D, which are buildings with religious function, in relation to ancestral customs, that form a community that shares the same family name. The community shared the responsibility to maintain the building, as part of their customs, that resulted in consistently good facade conditions.

**Figure 6.** Poor and excellent condition of building facades on Karet Street  
(Source: Author, 2025).

More focused interventions should be considered for zone F and G, where the material selection for the exterior facade of the building should be aligned with the design and history of the heritage corridor of Karet street. Choosing materials that resemble the original condition of the building could help match the building's design value as it was initially in the street corridor, while keeping the quality of the material up to date (Figure 6). Zone I should emphasize on preventive and protective measures for the building from improper modifications, as it has the most number of well-preserved buildings in it. The zone pictures a successful community driven preservation.
