SPATIAL SEGREGATION AND FACADE MAINTENANCE ALONG THE MUSI RIVER CORRIDOR ON DEPATEN BARU STREET

Stefani Widya Agustianti^{1*}, Abdul Rachmad Zahrial Amin¹, Dimitri Indah Puspita Sari¹,
Angel Aurellia¹, Denny Andika¹

¹Architecture Study Program, Musi Charitas Catholic University, Bangau Street No. 60, Palembang 30113, Indonesia

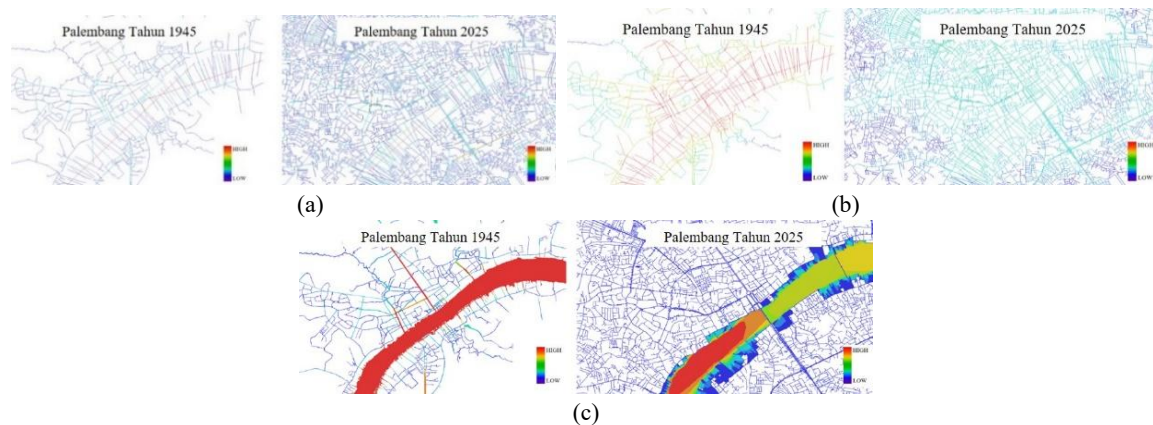
Figure 3. Levels of (a) Connectivity, (b) Integration and (c) Visibility of Palembang City in 1945 and 2025 based on DepthMapX Simulation Results
(Source: Author, 2026)

Image 3(a) is an axial image of the connectivity level of the road network in Palembang City in 1945 and 2025. Axial Image 3(a) shows a dominance of dark blue in both 1945 and 2025, with no apparent change in color category. Image 3(b) shows a change in the color category for the level of integration, which was dominated by red and yellow in 1945, while the 2025 map is dominated by dark blue and light blue. Image 3(c) shows that there is no change in the visibility level when viewed based on color categories because both are dominated by dark blue. Based on Image 3, the integration level shows a significant decrease compared to connectivity and visibility. The following is a table detailing the color classification, connectivity level, integration, visibility, and RRA measurements of Depaten Baru Street in both 1945 and 2025.

Based on the analysis results in Table 2, the connectivity value in the Depaten Baru Street corridor shows the same figure between 1945 and 2025, which is 4 with a light blue color category. This indicates that the level of direct road connectivity with other road sections has remained relatively unchanged. The results of the data analysis show

a significant decline in the integration value, from 1.17 in 1945 to 0.59 in 2025. This decline indicates that within the city's road network structure, Depaten baru street is no longer as well-integrated as it once was. A drastic decline also occurred in the visibility value, which dropped from 346 in 1945 to 47 in 2025. This change doesn't result in a noticeable contrast in color on the analysis map. The RRA value, increased from 0.85 to 1.66, indicating a strengthening of the degree of spatial segregation within that road network system.

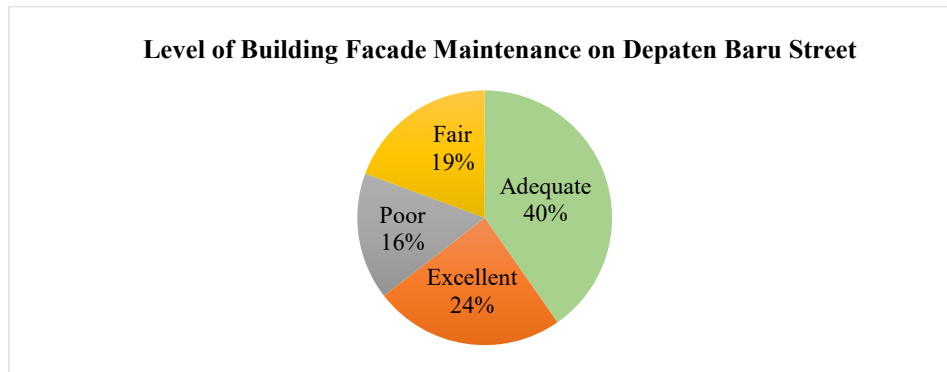
Figure 5. Level of Building Facade Maintenance on Depaten Baru Street
(Source: Author, 2026)

Based on the results of the physical condition identification of the buildings, Table 5 and figure 5 shows the level of maintenance of the building facades along the Depaten Baru street corridor based on maintenance categories. The adequate façade category dominates with 24 buildings or around 40% of the total sample observed. This indicates that most of the buildings on Depaten Baru street are still actively used. The facades of buildings along Depaten Baru Street are generally in adequate level. This condition is influenced by the presence of The Musi River, which is still used as a water transportation route in the city of Palembang. The ongoing activity along the riverbank means that this corridor continues to be used by the community.
