# ANALYSIS OF THE VULNERABILITY OF EDUCATIONAL FACILITIES TO THE LEMBANG FAULT EARTHQUAKE IN THE JAMBUDIPA VILLAGE AREA, CISARUA, WEST BANDUNG

Aldy Wicaksono<sup>1</sup>, Rayza Maulana Putra<sup>1\*</sup>, Feisal Andriananto<sup>1</sup>, Juarni Anita<sup>1</sup>

<sup>1</sup> Study Program Of Architecture, Faculty Of Architecture and Desain, National Institute of Technology, Bandung, West Java, Indonesia

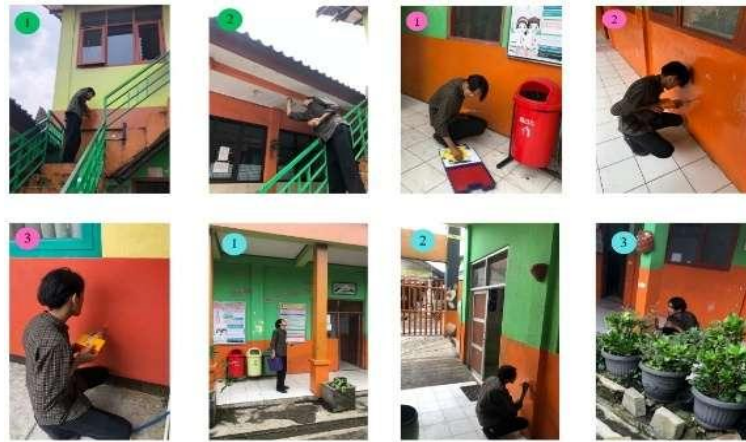
**Figure 7.** The Hammer Test Process at SDN 1 Jambudipa  
(Source: Personal Documentation, 2025).

**Table 2.** Results of the Hammer Test at SDN 1 Jambudipa

Average	Components	Direction of Fire	Floor	Conversion of Corrected Compressive Strength Values for Concrete in the Form of	
				Cylinder (f'c)	Cube (K)
29	Column	→	1	22	270.29
29.2	Column	→	1	22.5	276.43
28	Column	→	1	20	245.72
28.2	Beam	↑	1	21.5	264.14
28.5	Beam	↑	1	21	258.00
27	Wall	→	1	19	233.43
27.8	Wall	→	1	20.5	251.83

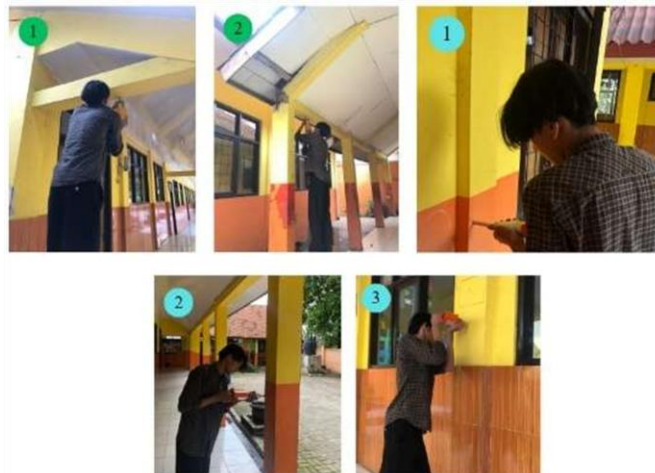
**Figure 8.** The Hammer Test Process at SDN 2 Jambudipa  
(Source: Personal Documentation, 2025).

**Table 3.** Results of the Hammer Test at SDN 2 Jambudipa

Average	Components	Direction of Fire	Floor	Conversion of Corrected Compressive Strength Values for Concrete in the Form of	
				Cylinder (f'c)	Cube (K)
30.2	Column	→	1	24	294.86
27	Column	→	1	19	233.43
26.1	Column	→	1	18.5	227.29
28.9	Beam	↑	1	22	270.29
23.9	Beam	↑	1	20	245.72
27	Wall	→	1	19	233.43
22.2	Wall	→	1	16.8	206.40

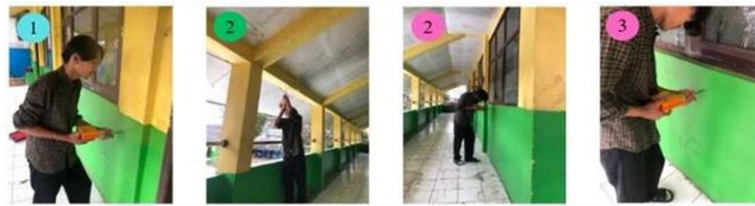
**Figure 9.** The Hammer Test Process at SDN Barukai  
(Source: Personal Documentation, 2025).

**Table 5.** Results of the Hammer Test at SDN Barukai

Average	Components	Direction of Fire	Floor	Conversion of Corrected Compressive Strength Values for Concrete in the Form of	
				Cylinder (f'c)	Cube (K)
32.2	Column	→	1	26.2	321.89
29.2	Column	→	1	22.1	271.52
30.4	Column	→	1	22.5	276.43
32.9	Beam	↑	1	26.2	321.89
29.7	Beam	↑	1	22.6	277.66
27	Wall	→	1	19	233.43
26.1	Wall	→	1	18.5	227.29

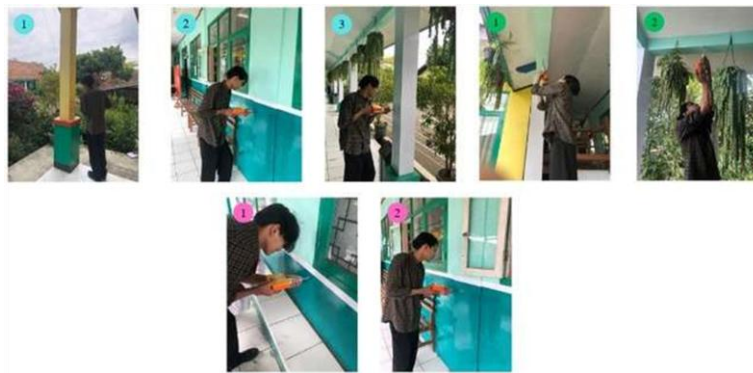
**Figure 10.** The Hammer Test Process at SDN Gandrung Endah  
(Source: Personal Documentation, 2025).

**Table 4.** Results of the Hammer Test at SDN Gandrung Endah

Average	Components	Direction of Fire	Floor	Conversion of Corrected Compressive Strength Values for Concrete in the Form of	
				Cylinder (f'c)	Cube (K)
27	Column	→	1	19	233.43
30.4	Column	→	1	22.5	276.43
23.3	Column	→	1	18.2	223.60
34.2	Beam	↑	1	24	294.86
30.1	Beam	↑	1	24.5	301.00
26.9	Wall	→	1	18	221.14
26	Wall	→	1	18.2	223.60

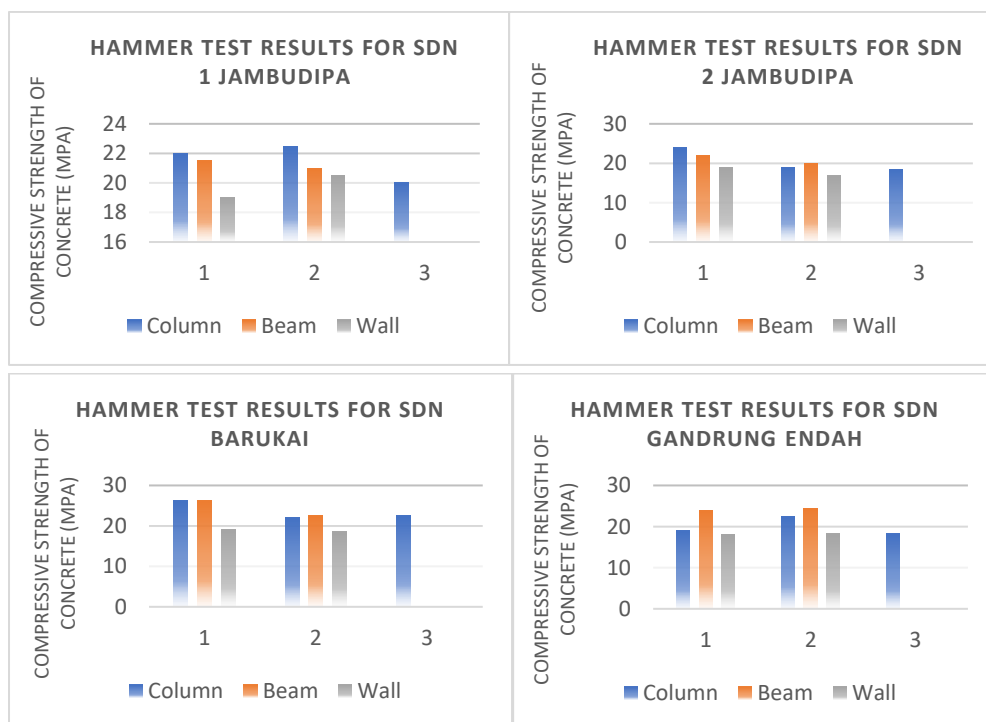
**Figure 11.** Summary of Hammer Test Results at the Four Schools  
(Source: Personal Documentation, 2025).

The results of the Schmidt Hammer test conducted at SDN 1 Jambudipa, SDN 2 Jambudipa, SDN Barukai, and SDN Gandrung Endah indicate that there are differences in concrete quality across various parts of the building structures. Based on the average test results, the compressive strength of the concrete in columns was 21.37 MPa, in beams was 22.72 MPa, and in walls was 18.62 MPa.

Based on the data shown in Table 1, K-225 concrete has a compressive strength of approximately 18.7 MPa, which is the minimum standard generally used for structures ranging from residential homes to educational facilities. According to this standard, most of the hammer test results for the four schools tested fell well within the K-225 range. However, it should be noted that for some hammer test points on certain structural components particularly wall components the values fell below the specified standard limit. These assessment results are considered a warning sign that some structural components may require further evaluation or repair.

The graph of the hammer test results shown in Figure 11 provides a summary of the compressive strength values of the concrete for the four school buildings that were the subject of this study. In general, the average concrete compressive strength values for the structural elements columns, beams, and walls did not show significant differences among the four schools. Columns have higher compressive strength values compared to beams and walls because they serve as the primary load-bearing structural elements. In contrast, wall elements have lower compressive strength values. Although there are slight -

differences among the four buildings, the overall results of this test indicate that the concrete quality at the four schools is relatively similar, with no major differences. Therefore, the results of this Hammer Test can be used to provide an initial assessment of the condition of the building's structural elements and serve as a basis for conducting more detailed follow-up inspections if necessary.

Given that Jambudipa Village is located near the still-active Lembang Fault, it is recommended that further structural evaluations be conducted using more comprehensive methods. Regular, large-scale maintenance is necessary to ensure the long-term safety and resilience of these buildings, especially given the ongoing risk of earthquakes in the Lembang Fault zone.
